3M ESPE

Making Better Impressions

Trouble

Shooting
Guide

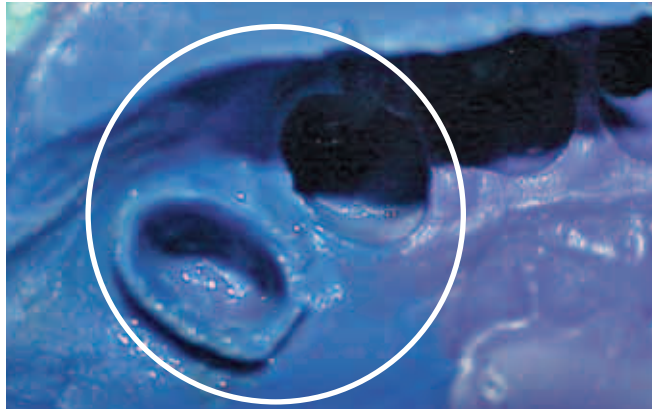
Visual Appearance: Impression not completely set. Shiny, no detail of site.

Result: Inadequate surface detail on stone cast, poor fitting restorations.

Sulfur inhibition due to contact of latex gloves with tissue/tooth/retraction material or impression material.

Residues from custom temporary or provisional cements (acrylics) present.

Inhibited Setting

Wear gloves proven not to contain traces of sulfur.

If contamination is suspected, scrub affected area with diluted hydrogen peroxide.

Do not use impressions already used to fabricate the temporary restoration.

Fabricate the temporary crown or bridge after final impression has been made.

Remove air-inhibited layer on the exposed surface with an alcohol wipe before making final impression.

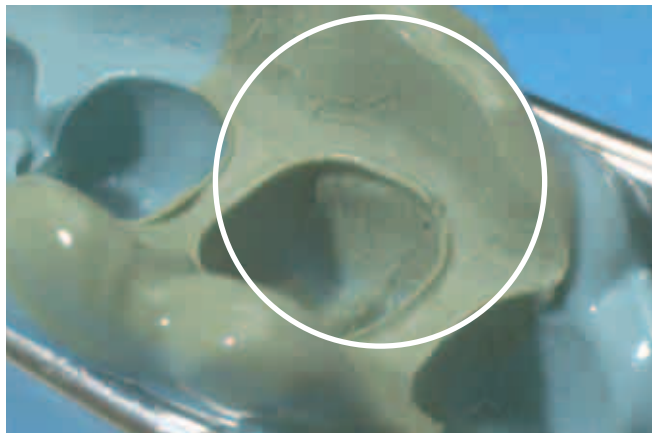
Surface Inhibition

Substances with pH < 4 inhibit setting reaction, most commonly by the contact with acidic retraction materials and hemostatic agents containing epinephrine or ferric sulfates.

Use retraction materials having pH ≥ 4 .

Select retraction materials and hemostatic agents not containing these chemicals.

Rinse, remove, dilute hemostatic solution with water spray and suction. Dry before taking the impression.

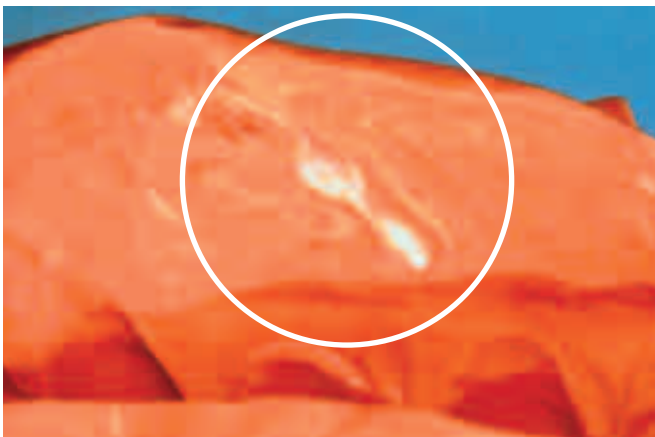
Inadequate mix.

Inadequate Mix

Bleed before applying mix tip to ensure even dispensing.

Use mix tip according to manufacturer's instruction for use.

Ensure mix tip is correctly attached.

When using hand-mix materials ensure correct mixing ratio and thorough mix of catalyst and base paste.

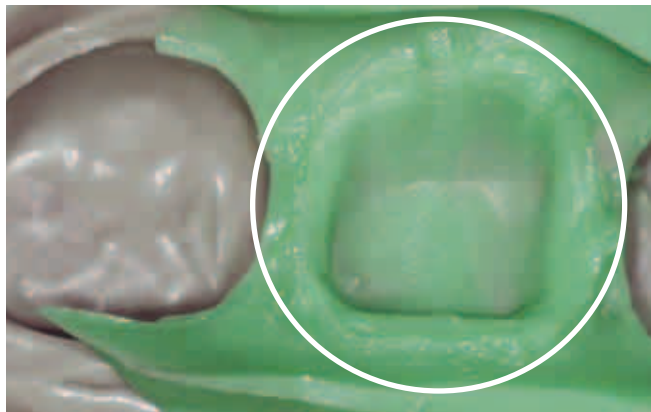
Visual Appearance: Muted detail reproduction.

Result: Crowns may be too tight, or loose, and not fit correctly.

Lack of Impression Detail

Incorrect storage conditions of the final impression affects surface quality (detail reproduction) and dimensional stability.

Rinse polyether impressions with water and blow dry before sending it to the lab.

Do not send the impression in the same bag as an alginate impression to the lab.

Avoid storing impressions in sealed bags.

Store the impression at room temperature away from direct sunlight.

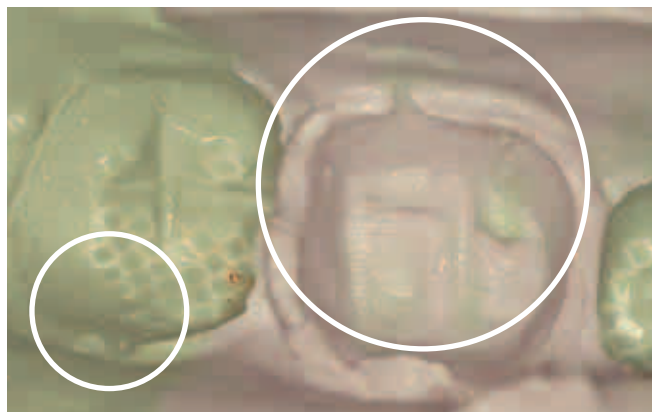
Visual Appearance: Voids/holes on margin of the prepared teeth. Incomplete margin.

Result: The fit and function of the final restoration may be compromised. Short crown margins and/or open margins.

Void Caused by Syringe Technique

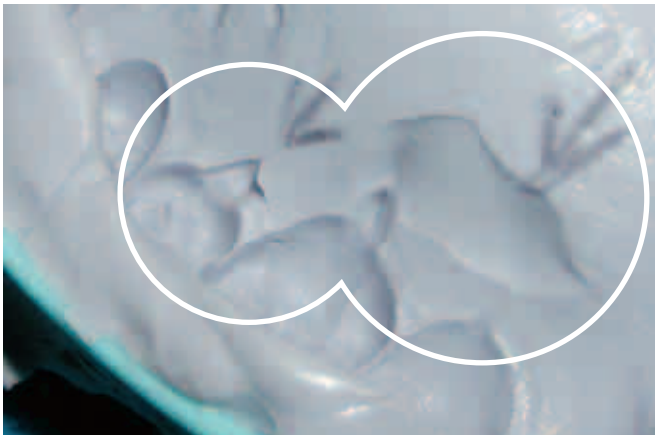
Blood and saliva contamination around prep.

Trapped Air or Moisture

Use good moisture control technique. Rinse and dry prep area before taking the impression.

Stop bleeding by using appropriate retraction technique and hemostatic agent. Leave cord in sulcus until no blood or saliva are present before syringing the light body impression material. Consider two-cord retraction to displace tissue and control fluids.

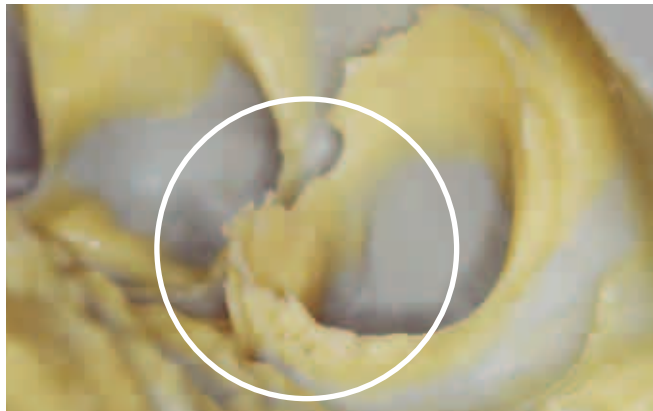
Visual Appearance: Rip, or visible tearing on the margin of the preparation.

Result: Short crown margins and/or open margins.

Poor Retraction — Insufficient Tear Resistance

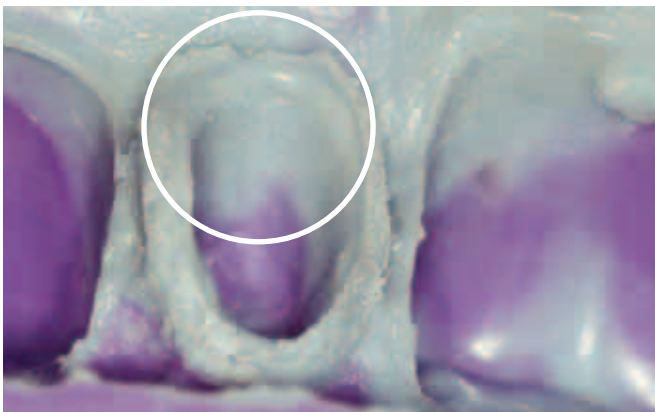
Tearing at the Margin

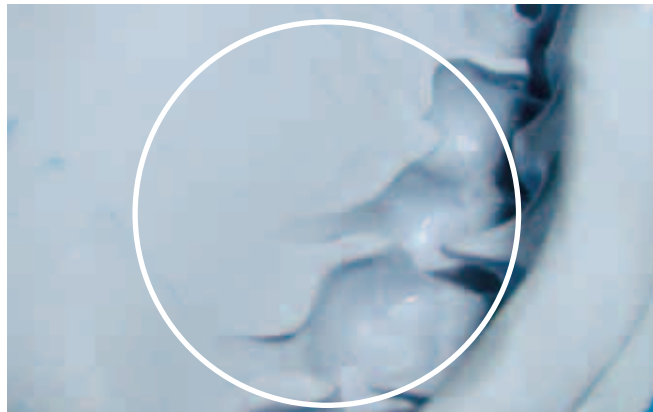
Visual Appearance: V-shaped void, trough-like.

Result: Failure to capture complete and accurate dentition.

CAUSE	SOLUTION
Exceeding the working time.	Follow manufacturer's working time specifications. Choose material with longer working time.
Tray movement or repositioning after seating.	Do not move tray after seating.
Insufficient amount of impression material used.	Use more material to create back flow effect.
Impression tray does not support flow of impression material.	Use lingual stops. Use an impression tray that supports the flow of the material.

Lingual Pulls

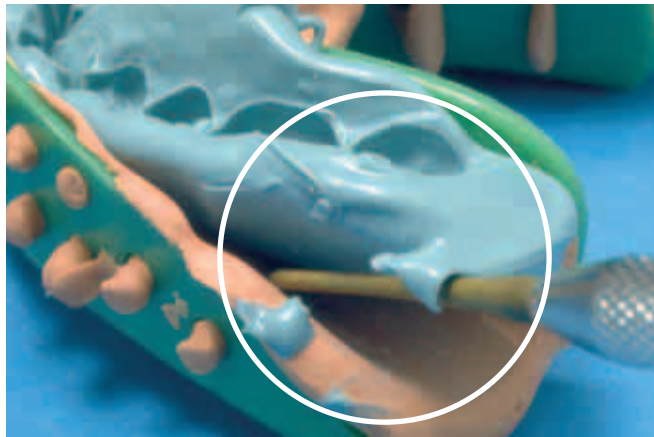
Visual Appearance: Heavy body and light body materials not blended, or mixed together.

Result: Restoration will not seat or fit properly.

CAUSE	SOLUTION
Exceeding the working time.	Follow manufacturer's working time specifications. Choose material with longer working time.
Impression material stored at elevated temperature.	Store impression material at room temperature.

VPS	SOLUTION
Sulfur or acrylic contamination of pre-set heavy body material in two-step technique.	Avoid contact with sulfur contaminants: Wear gloves proven not to contain traces of sulfur. Avoid contact with acrylic and methacrylic contaminants: Ensure impression material does not come into contact with methacrylate residue from acrylate temporary materials.

Poor Bond Between Heavy Body and Light Body Material

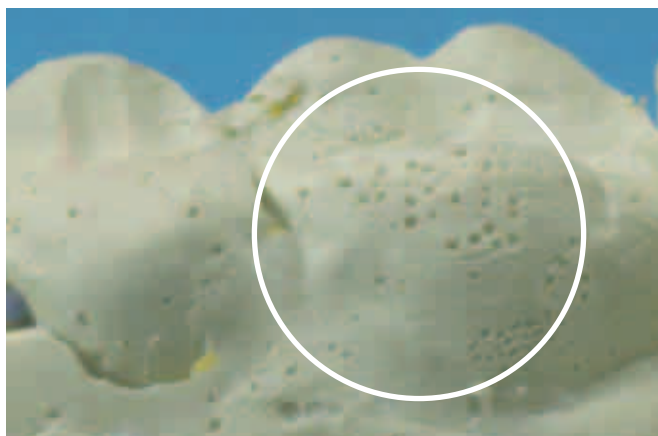
Hydrogen gas emission.

Stone Model with Hydrogen Evolution Voids

Follow manufacturer’s instruction for casting time.

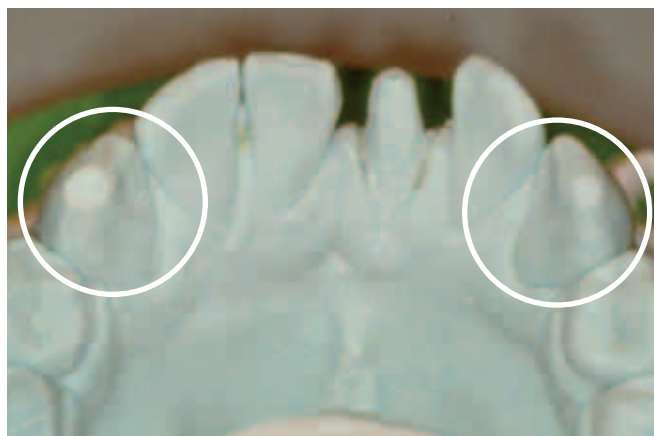
Visual Appearance: Voids on margin, powdery cusp tips on incisal edges on prepared tooth. “Golf-ball” appearance of stone model.

Tooth contact with impression tray, or gauze of double bite tray causes water to leach out of the tray, dehydrating the stone.

Stone Model with Powdery Cusp Tips

Instruct patient to bite passively in centric occlusion when using dual arch trays.

Fill tray with sufficient amount of material.
